**Comments on the Environmental Impact Assessment for the
Proposed Entertainment Complex at Seventh Harbour Marina,
Palisadoes Road, Kingston by Treasures Limited 200501017-
EP00262, 2005-01017-EP00263, 2005-01017-BL00061, 2005-01017-
EP00261/EL00045**

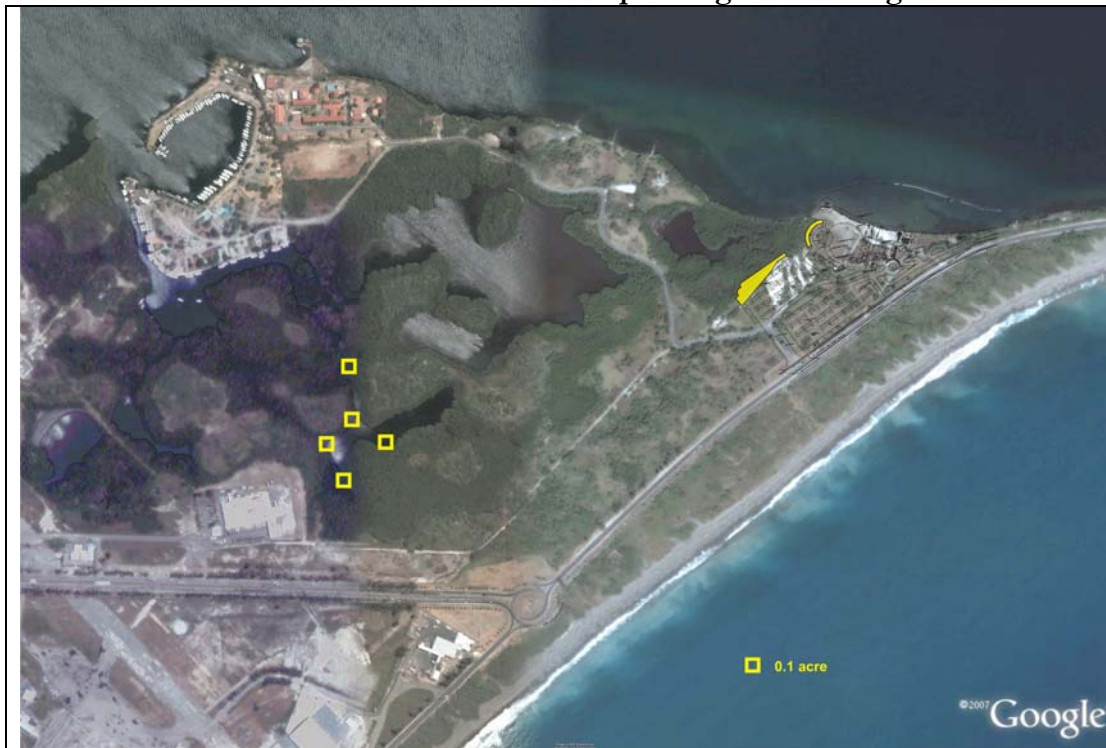
Approximately 0.5 acres of wetland vegetation will be removed to facilitate the parking area. Viable specimens will be relocated to an area earmarked for rehabilitation within the larger wetland complex to the west of site. The figure below identifies areas that have been identified for replanting of the mangroves.

2. *The information on what percentage of the mangroves surrounding the project site will be removed should be provided.*
Approximately 0.5 acres on the western side of the parking lot will be encroached on.
